BUILDING INSPECTION REPORT

Prepared for: Buyer
Property: 300 Private Pl., Unit #4
Brooklyn, NY
Inspection Date: April 17, 2005
Report Number: BR-041705-1

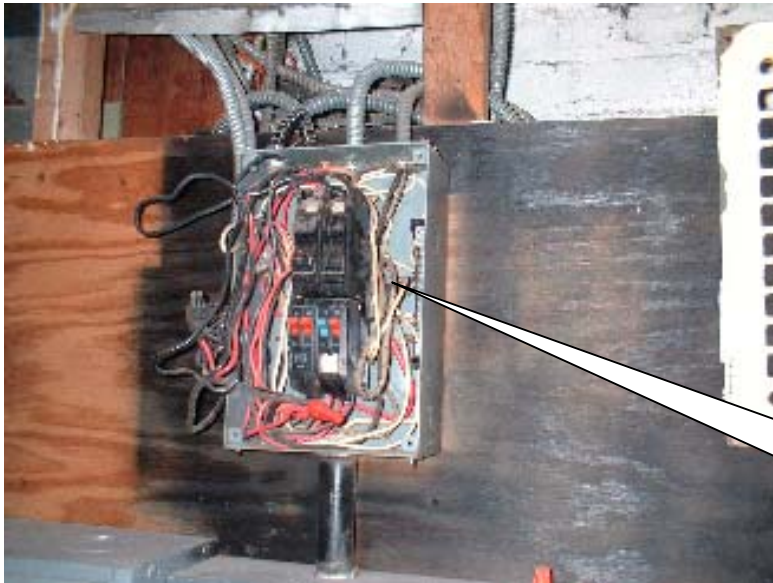
Fig. 1

The electrical system in this building is not in compliance with the New York City Building Department regulations pertaining to exposed electrical distribution panel wiring in the basement (Figs. 1 and 2) and exposed transformer wiring in the boiler room (Fig. 2). Open or unsecured panel-box covers present electrocution hazard. Panel-box covers should be securely in place at all times. Similarly, the door to the boiler room should be securely locked to prevent children and adults from accidentally coming in contact with the high voltage feeding the transformer primary. The seller and the buyer are strongly encouraged to bring this potentially dangerous condition to the attention of COOP association.

Exposed electrical wiring presents electrocution hazard to persons coming in contact with high voltage.

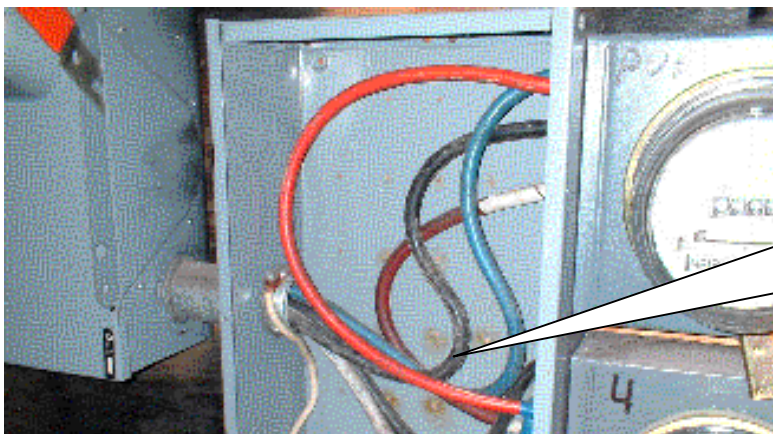
The unsecured panel-box cover presents electrocution hazard to persons coming in contact with live high voltage wires.

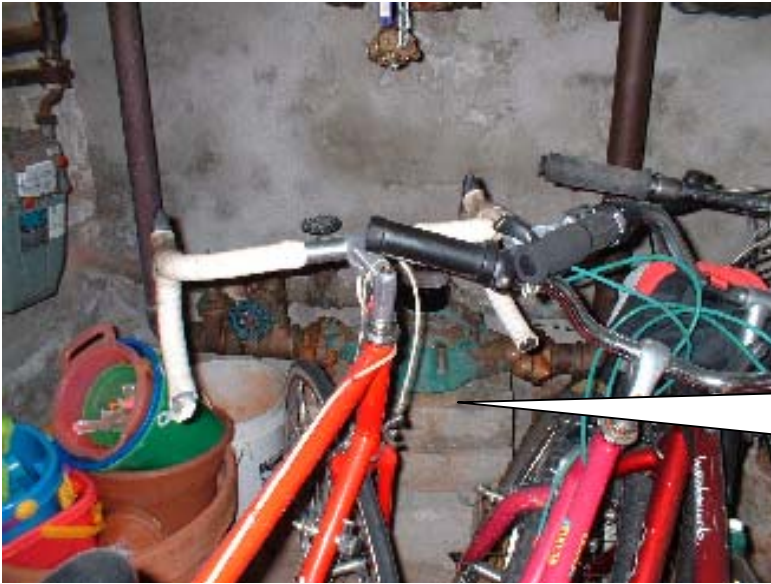
Fig. 4

Water meter is improperly supported by paving stones. Proper pipes supports should be utilized.

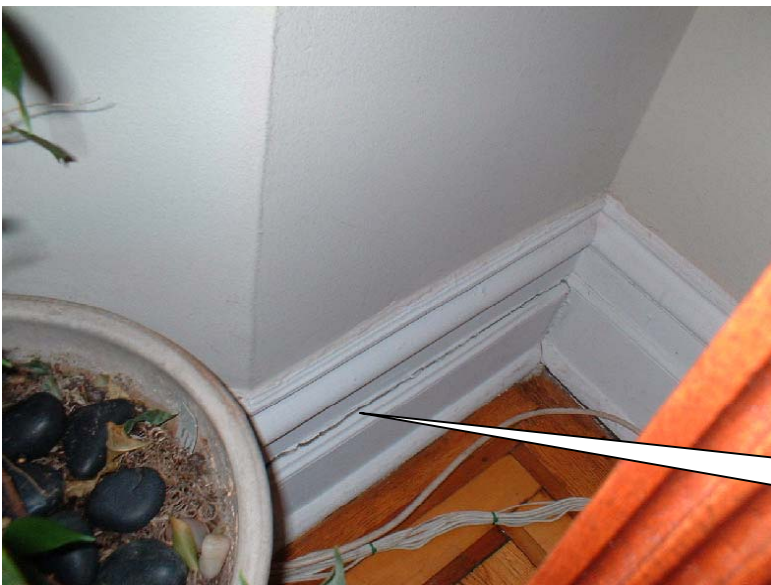
Fig. 5

The flooring in Unit #4 is hardwood and ceramic tile floor laid over a sub-floor supported by joists and beams, which in turn are supported off the walls at the edges. All flooring is worn, however it feels sufficiently solid when walked upon, with only minor hardwood floor creaks, and overall appears to be normal for the building of this construction type, size and age. One notable exception is the perceptible sag in the family room. The amount of sag is evidenced by the crack in the exterior wall base molding (Fig. 5).

Crack in base molding due to floor settling.

We recommend professional inspection and repair of sub-floor in the family room when remodeling.

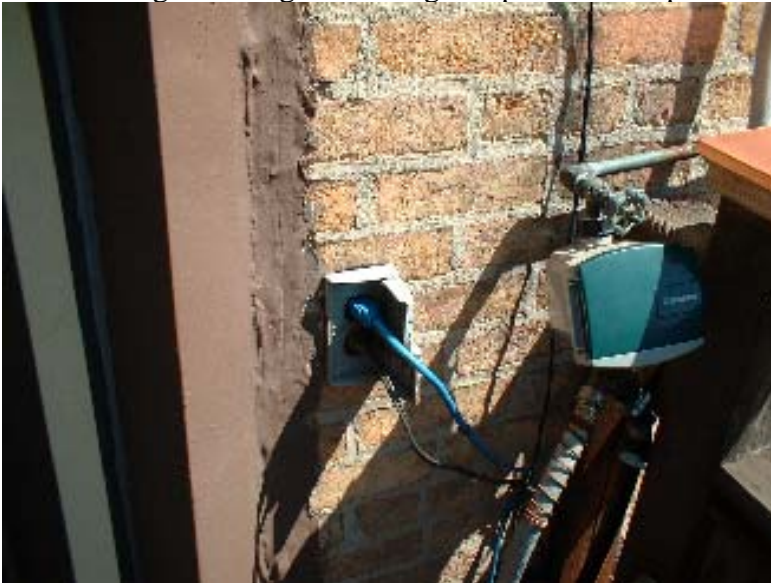
Fig. 6

There is an electrical extension cord in use outdoor (Fig. 6). This type of extension cord is not appropriate for outdoor use. Improper use of extension cords may cause personal injury, and result in damage to the electrical circuits and potentially, fire. We recommend the extension cord be removed to avoid fire hazard.

The outdoor electric outlet in Unit #4 is not fitted with a ground fault circuit interrupter (Fig. 6). Not complying with this National Electrical and local Building codes requirement may cause personal injury, and result in damage to the electrical circuits and potentially, fire. We recommend that GFCI receptacle be installed outdoor as required by current building code.

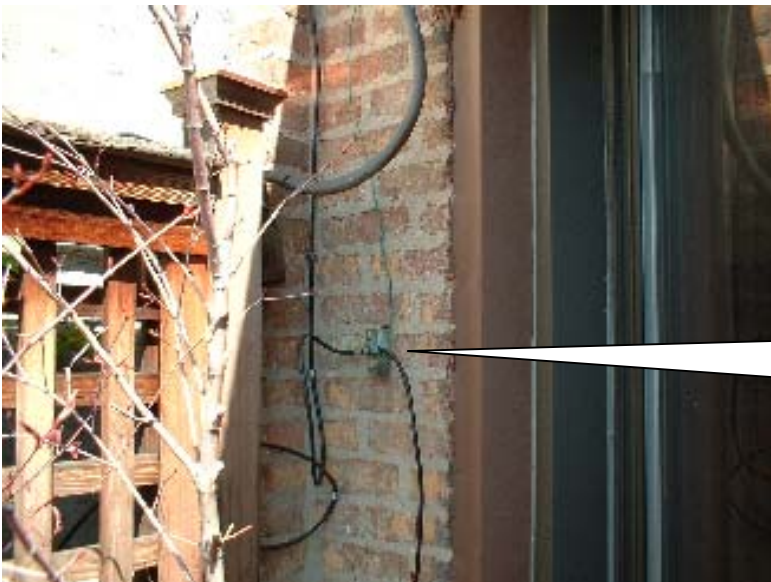
Fig. 7

The electrical system in Unit #4 does not meet today’s National and local electrical and fire prevention codes pertaining to grounding of aerial antenna (Fig. 7). The antenna (satellite dish) cable is improperly grounded to an un-grounded electrical conduit.

Improper grounding of aerial antenna may result in damage to appliances in the event of a lightning surge.
